**Association of Wall & Ceiling Industries
Australia & New Zealand**

PLASTERBOARD RECTIFICATION RESULTING FROM FLOOD INUNDATION

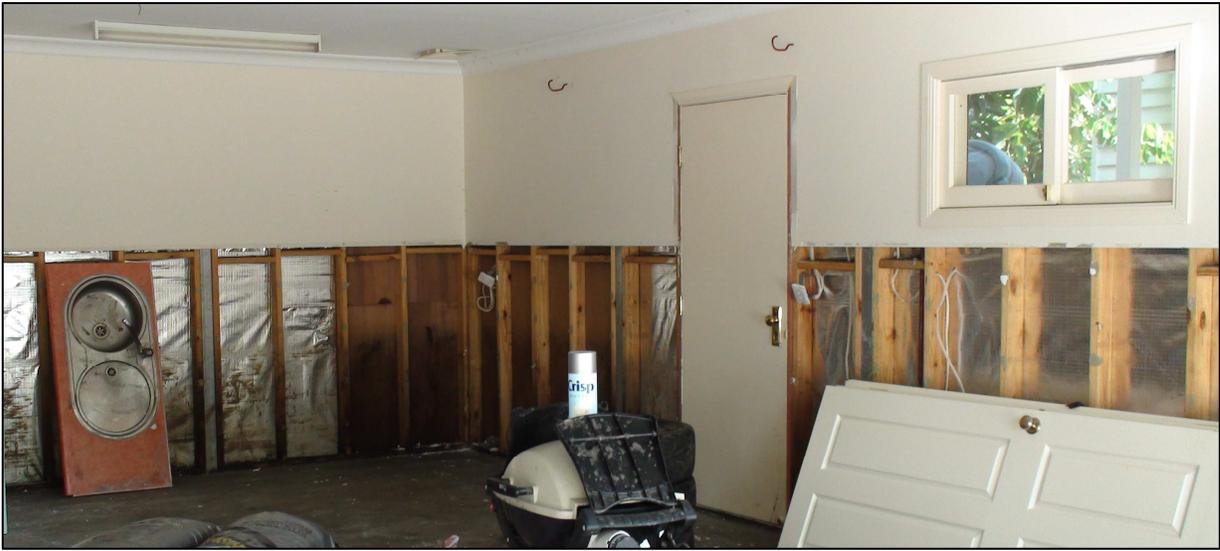
Method 1

Remove the damaged sheets to approximately 300mm above the high water mark preferably at the nearest joint above the water line. Given sheets are either 1200 mm or 1350 mm high it will either be at these joints or at full wall height (see 2 below).

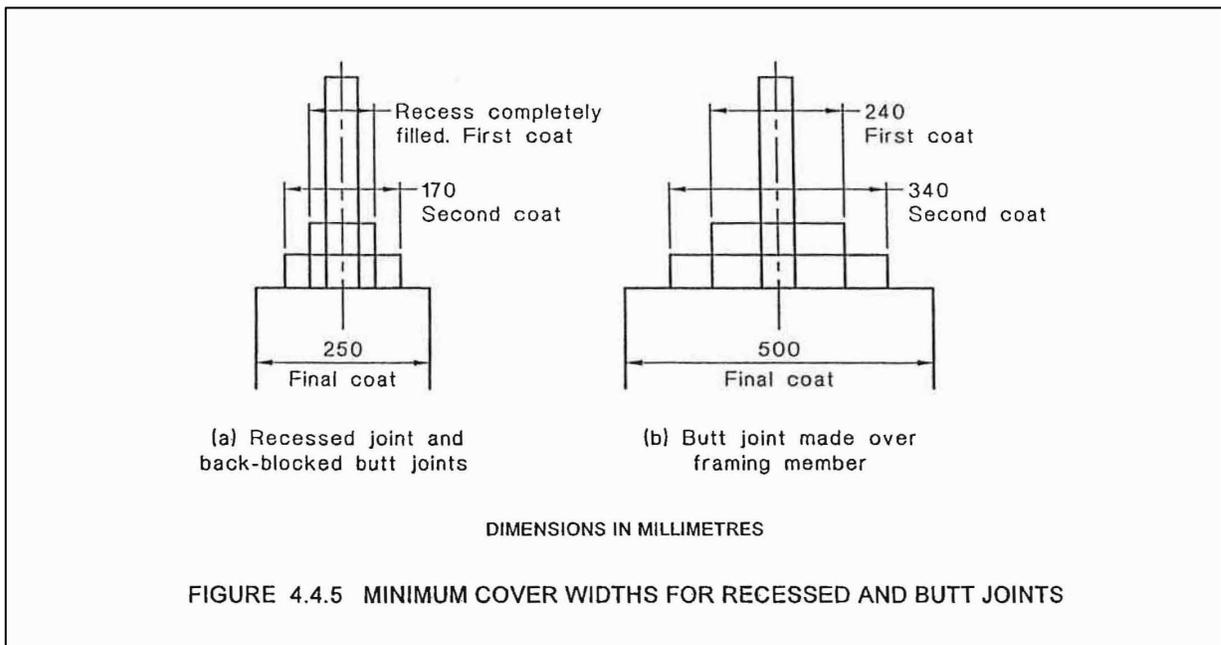
Because the replacement joint will most likely be made up of one new recessed edge board abutting the existing sheet (a butt edge), the joint should be treated as a butt joint. There will be a crown created which may cause glancing light issues and setting out over 600mm (the same as a butt joint) will reduce the noticeability of the crown. See the Australian Standard AS/NZS 2589:2007 (Figure 4.4.5) for more information on setting out for butt joints. Note: A decorative dado rail may also be used over the new joint without the requirement of trowelling.
